**LAKES IN**  
**KALYAN-DOMBIVLI MUNICIPAL CORPORATION LIMITS :**  
**A STUDY REPORT**

**(LAKE VASAR)**

Ref.No. BET/2001/MMRREF

Dt. 22<sup>nd</sup> Sept., 2001

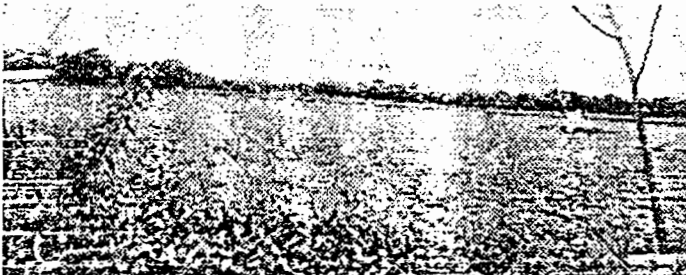
निळजे गावातील पाणयनस्पतींनी भरलेला तलाव. (छायाचित्र : प्रदीप गोसावी)

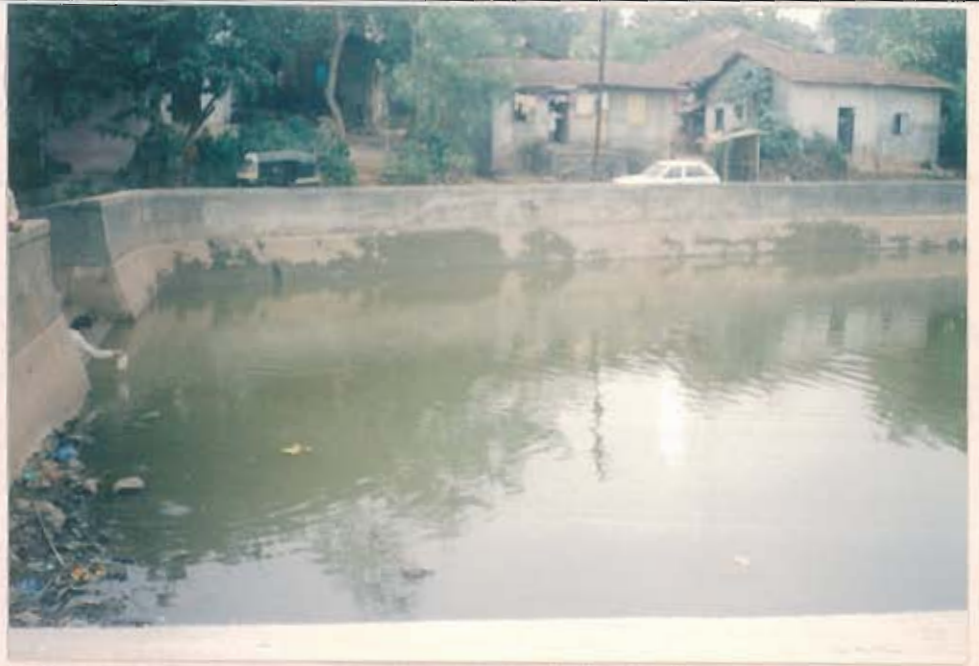
*LAKE : NANDIVALI*

*CATEGORY OF LAKE : EXCELLENT*

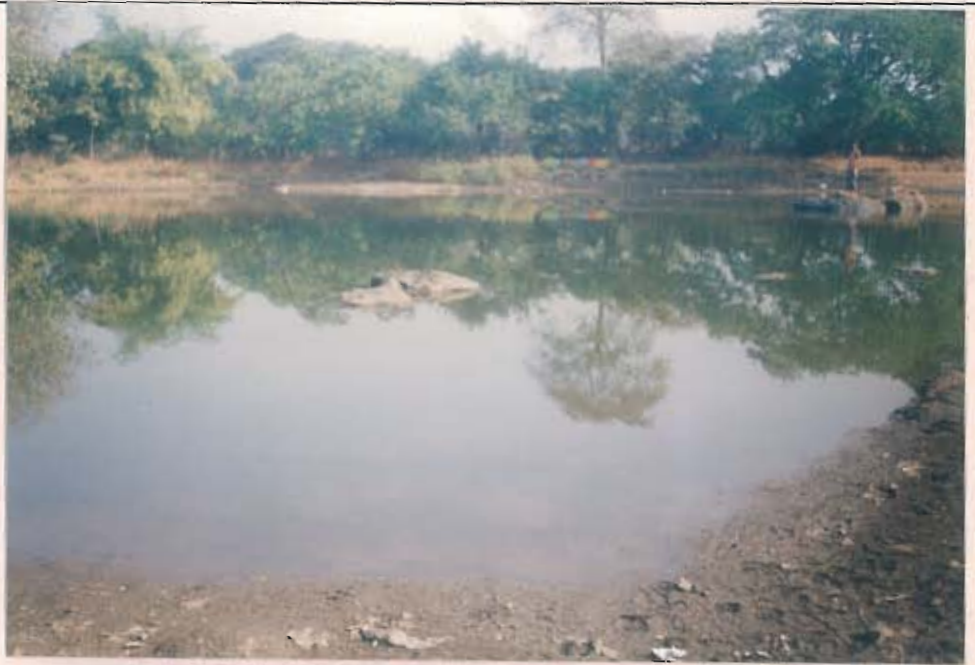
*LAKE : SONARPADA*

*CATEGORY OF LAKE : IMPACTED*

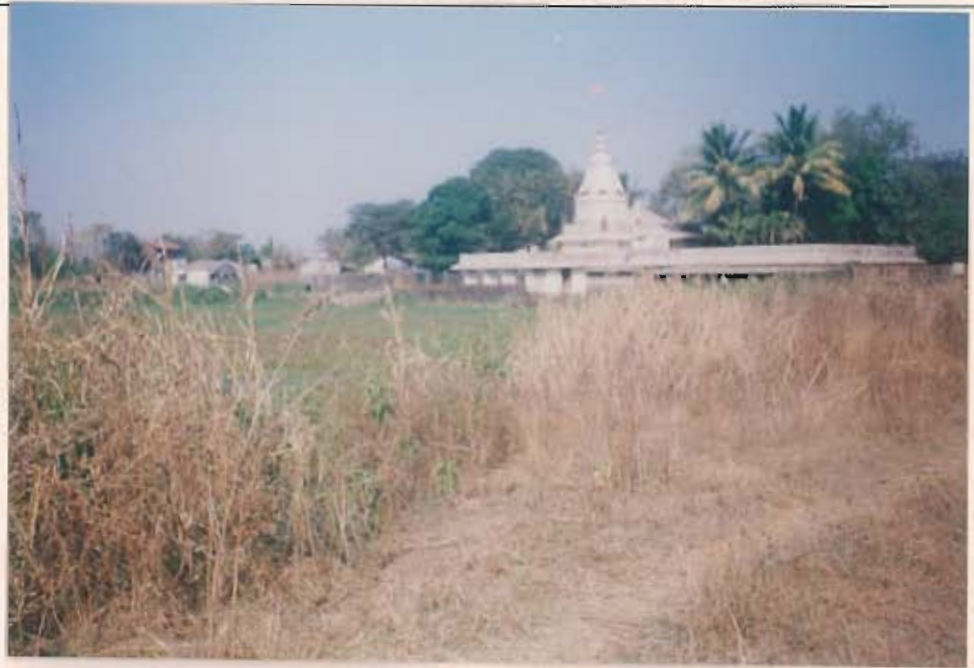
*LAKE : TITWALA GANAPATI MANDIR*

Ganapati Mandir being famous pilgrim centre , deteriorated state of the lake needs urgent attention.

*CATEGORY OF LAKE : SEVERELY IMPACTED*
