**PROJECT REPORT**  
**ON**  
**REPETITIVE WATER LOGGING**  
**IN THANE CITY**  
**ENGINEERING SOLUTIONS**  
**AND**  
**ENVIRONMENTAL MANAGEMENT PLAN**

(SPONSORED BY THE MMR ENVIRONMENT IMPROVEMENT SOCIETY)

**(FINAL REPORT)**

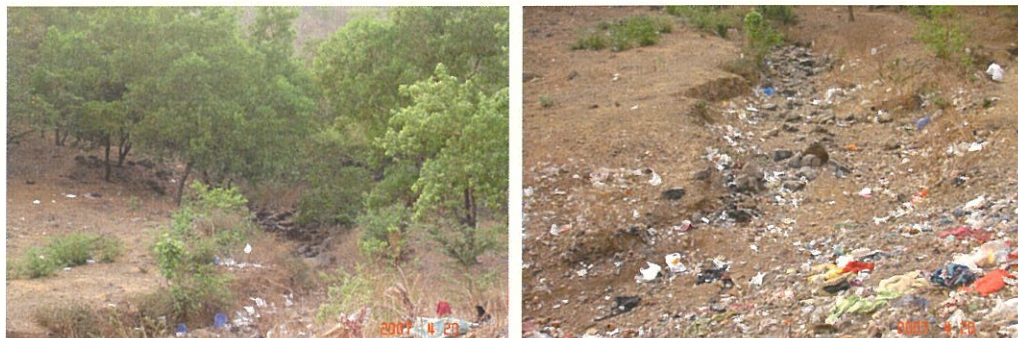
**5.4.1 BOULDERS AND ROCKS ENTERING INTO THE WATERCOURSES AT THE ORIGIN**

- a] The velocity of natural watercourse flowing from the hills during rainy season gets reduced when it reaches relatively plain area. It is observed that at the foot of the hills there are structures within 6 to 8 feet of both sides of watercourse spread over considerable length, making it inaccessible for machine cleaning. Even manually it is difficult to lift big boulders and

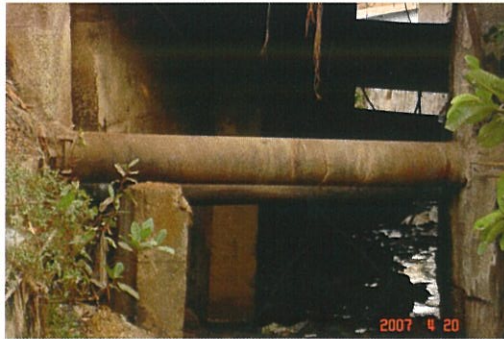
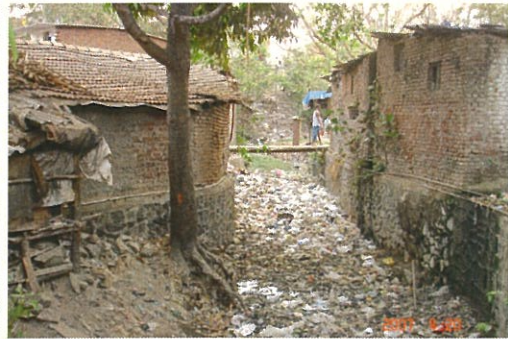
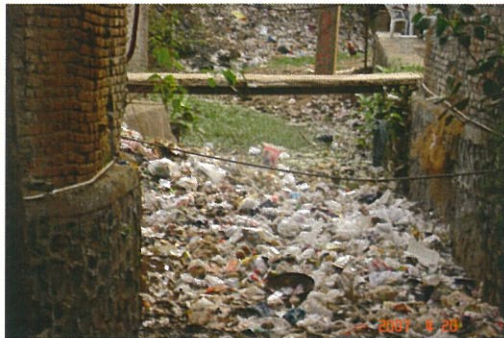
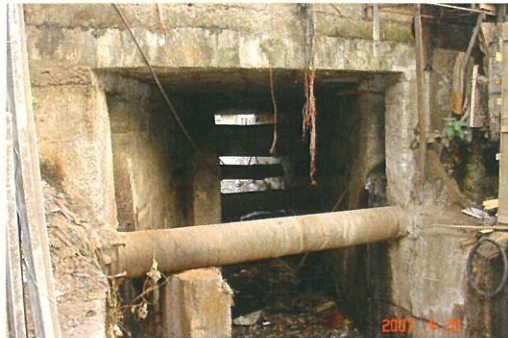
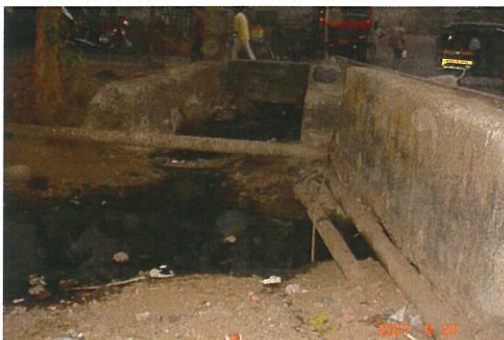
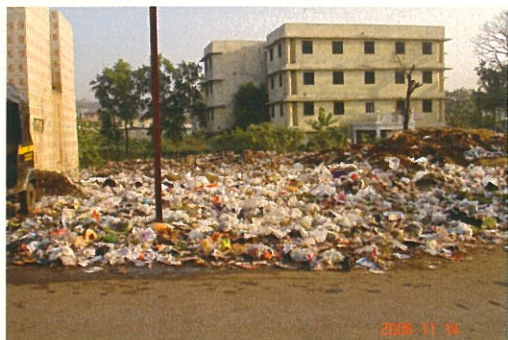
**5.4.2 UTILITIES PASSING THROUGH, DUMPING OF GARBAGE,  
PLASTIC WASTE, ETC.**

- b] Solid waste and plastics are dumped by people residing in the close vicinity of watercourse and sullage flowing in the watercourse make manual cleaning still difficult.
- c] The utilities in the watercourse cause accumulation of silt, plastics and solid waste, further restricting the flow (Anandnagar).

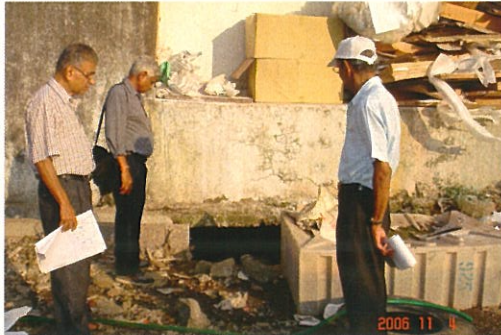
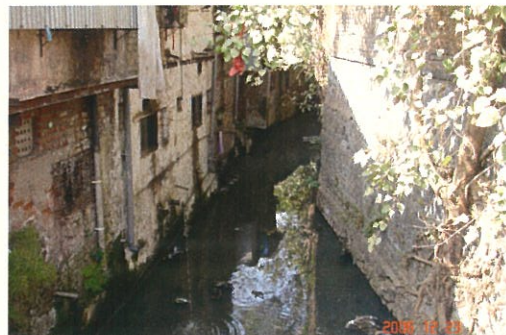
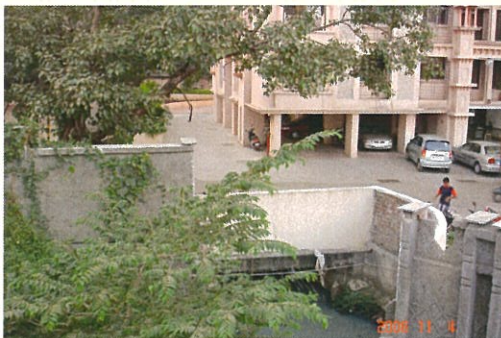
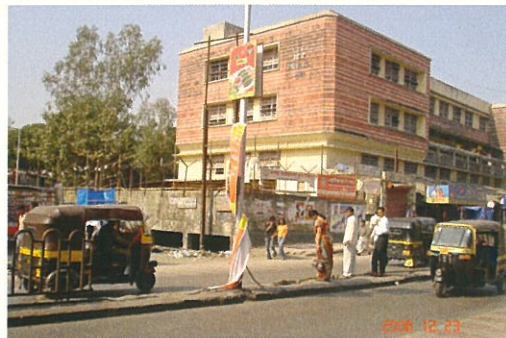
**5.4.3 HUTMENT COLONIES, UNAUTHORIZED PUCCA  
CONSTRUCTION ACROSS AND OVER THE WATERCOURSES**

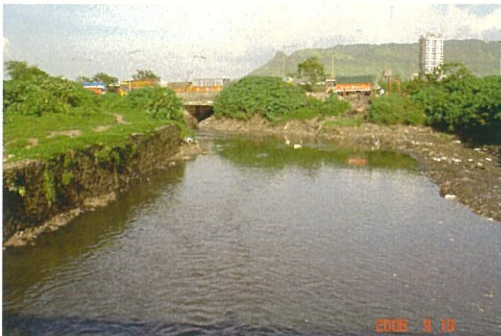
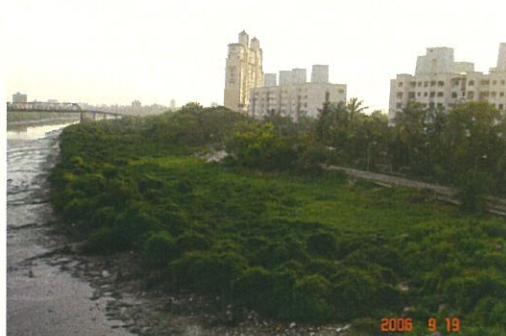
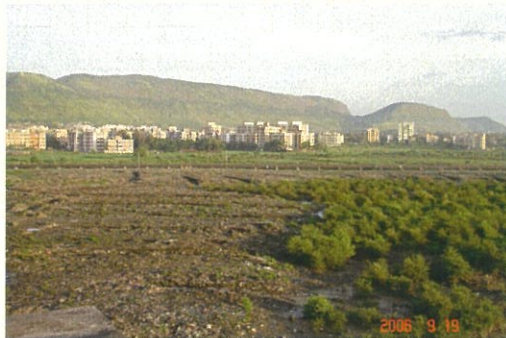
**5.4.4 UNAUTHORIZED CONSTRUCTIONS IN CRZ AREA, DUMPING IN  
THE CREEK AND DESTRUCTION OF MANGROVES**

- b] Unauthorized constructions in CRZ-2 areas. (Diva – Dativali & other areas)
- c] In many cases the watercourses have become narrow in the down stream because of authorized or unauthorized structures (including multi-storied buildings) or deliberately narrowing of watercourse by developers. The high run-off from the hills flowing in relatively wider watercourse on the upstream is subjected to quite inadequate carrying capacity of narrower watercourse on the downstream, causing overflow particularly in low lying area.

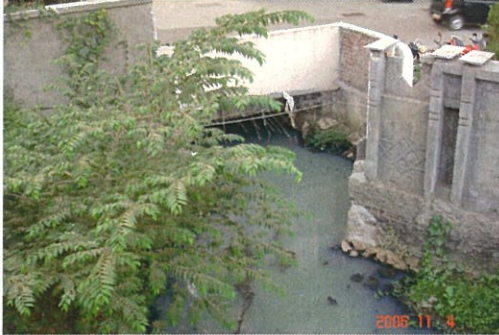
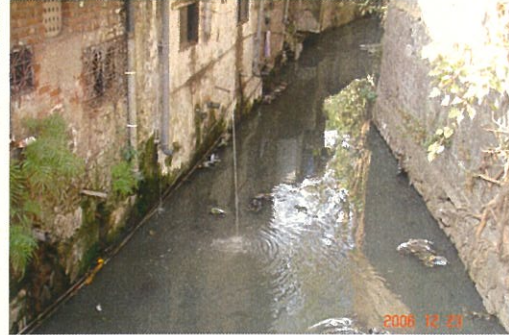
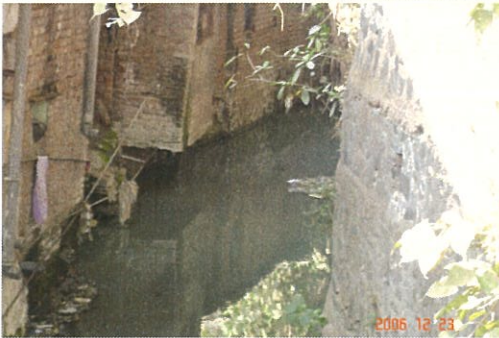
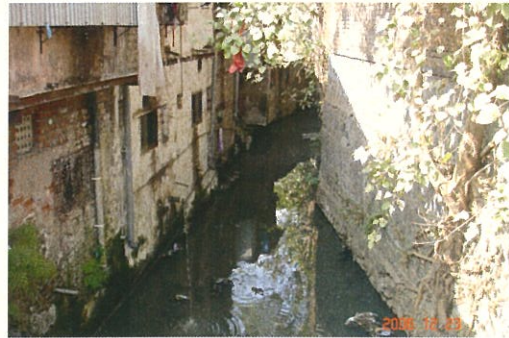
**5.4.5 UNNATURAL NARROWING DOWN OF WATERCOURSES  
ACROSS THE RUN-OFF**

Apart from the common reason of obstructions to the flow such as utilities in the watercourse and solid waste dumping by people, a specific cause observed under this category is narrowing and turning the watercourse 90° or so by the developer for his convenience, and also construction of compound wall, concrete parking area or concrete play ground of school etc. on the watercourse (Tarangan, Shubharambh Society on WC 10, M H High school compound wall and its play ground, etc.).

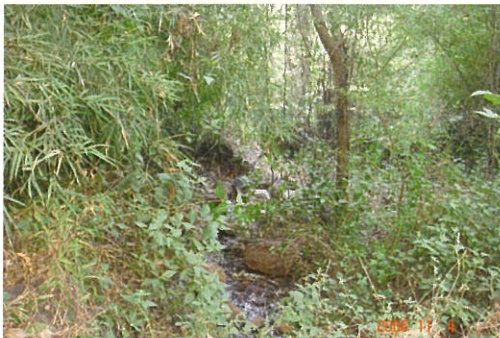
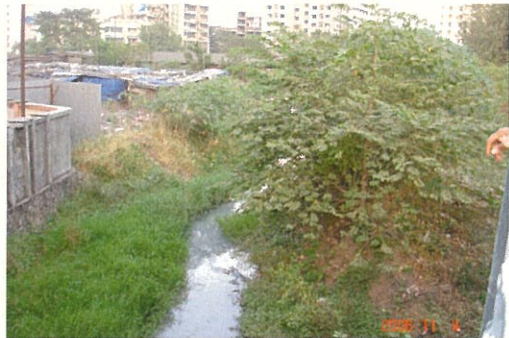
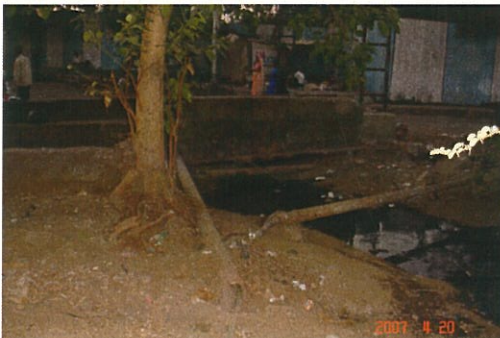
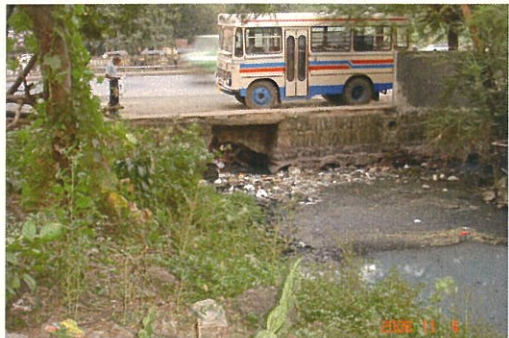
**5.4.6 CHOKING OF CULVERTS, RUN-OFF AREA, UNTRAINED  
NALLAS, ETC.**

The size of Railway culverts constructed many years before has not been increased to meet the needs of the high co-efficient of run-offs of the growing city. This causes water logging mainly in the areas surrounding watercourses in Thane East (Downside of Kopari, Anand Talkies, Chendani Koliwada).

- d] Inadequate carrying capacity and skewed alignment (Road No.34, TMT depot in Railadevi Prabhag).
- e] Inadequate cross-drainage, inadequate culverts (Kamgar Hospital, Bradma Company, Runwal Junction in Vartaknagar, etc.).
- f] Dumping of solid wastes by people (Ann-II – Page 88).

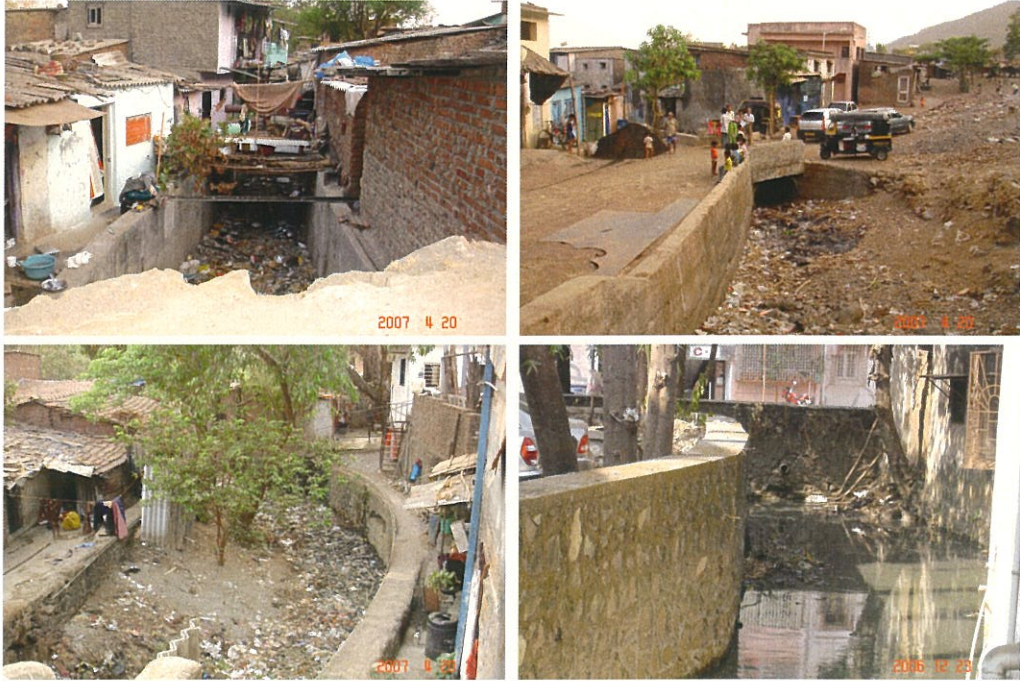
**5.4.7 MULTIPLE OBSTRUCTIONS**
